Manhole Inspection Summary

Manhole # S43KK_036MH

Insp Date: **3/1/10 1:47 PM**

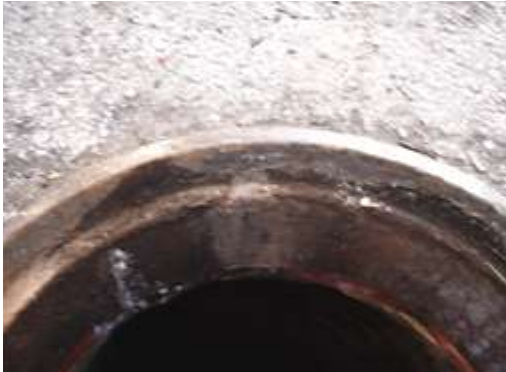
Defect 3

Frame Offset: **0.5** (in.) Condition: ☐ Sound ☐ Cracked ☒ **Leaks**

frame leaks

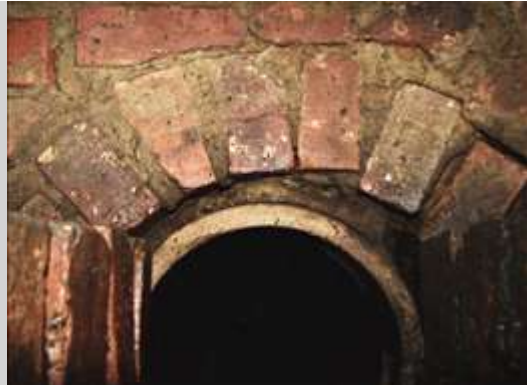
12 O'Clock Outflow

8 in. Circular Gravity Sewer
Pipe Out @ 12 O'Clock

Pipe Height: **12** (in.) Rod and Bar (Angled)
Pipe Material: **Clay** ☐ Pipe Lined
Invert Depth: **9.25** (ft.) Flow Characteristics: **Fast**
Deposits: ☒ None ☐ Mud ☐ Sludge ☐ Debris ☐ Grease
Silt Depth: (in.) Deposits Extent:
Infiltration: **None** Pipe Seal Cond: **Sound**

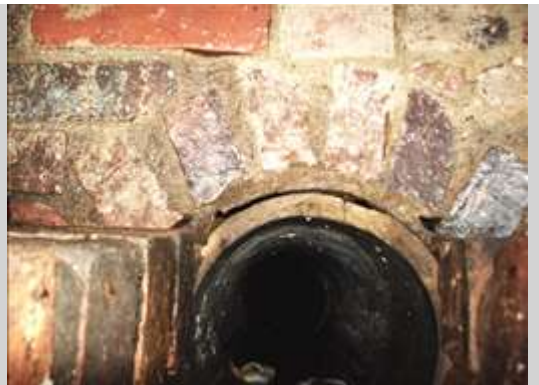
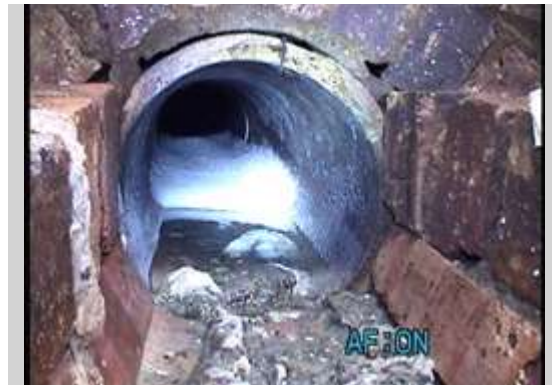
6 O'Clock Inflow

8 in. Circular Gravity Sewer
Pipe In @ 6 O'Clock

Pipe Height: **8.4** (in.) Rod and Bar (Angled)
Pipe Material: **Clay** ☐ Pipe Lined
Invert Depth: **8.20** (ft.) Flow Characteristics: **Fast**
Deposits: ☒ None ☐ Mud ☐ Sludge ☐ Debris ☐ Grease
Silt Depth: (in.) Deposits Extent:
Infiltration: **None** Pipe Seal Cond: **Sound**
